Pine Creek Streambank Rehabilitation

Schuylkill River restoration Fund and BCCD Clean Water Fund

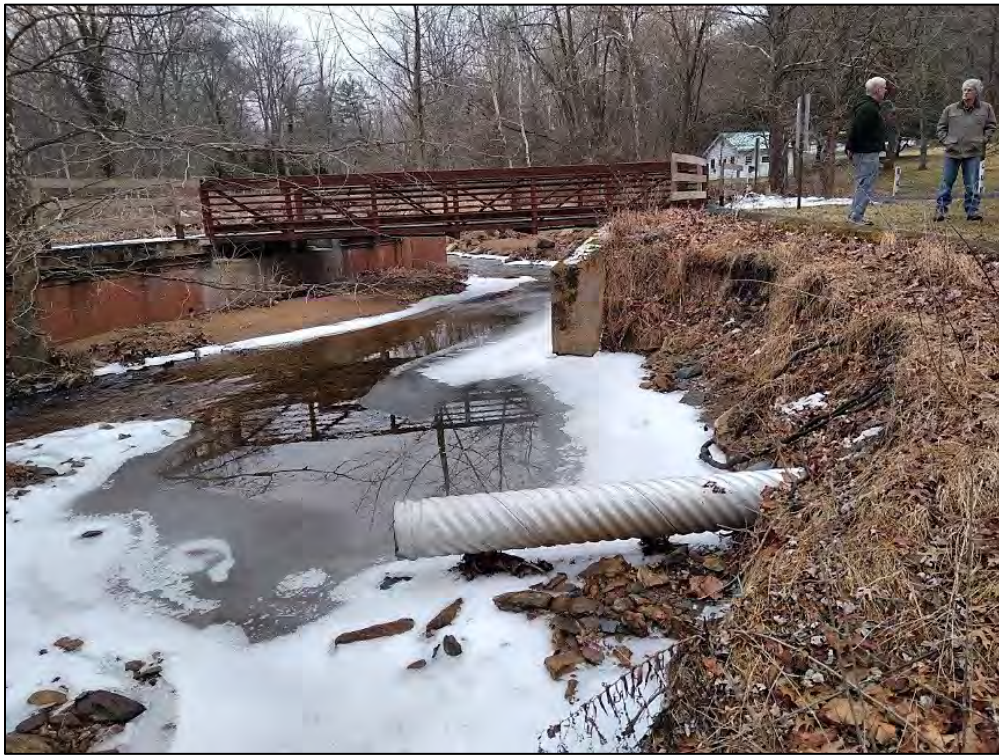
Figure 1: Back-to-back storms has scoured out ~ 8 ft. of streambank next to Township foot bridge abutment and Coult Property. Active erosion and significant downstream sedimentation is visible on Pine Creek an Exception Value stream in Pike Township, Berks County.

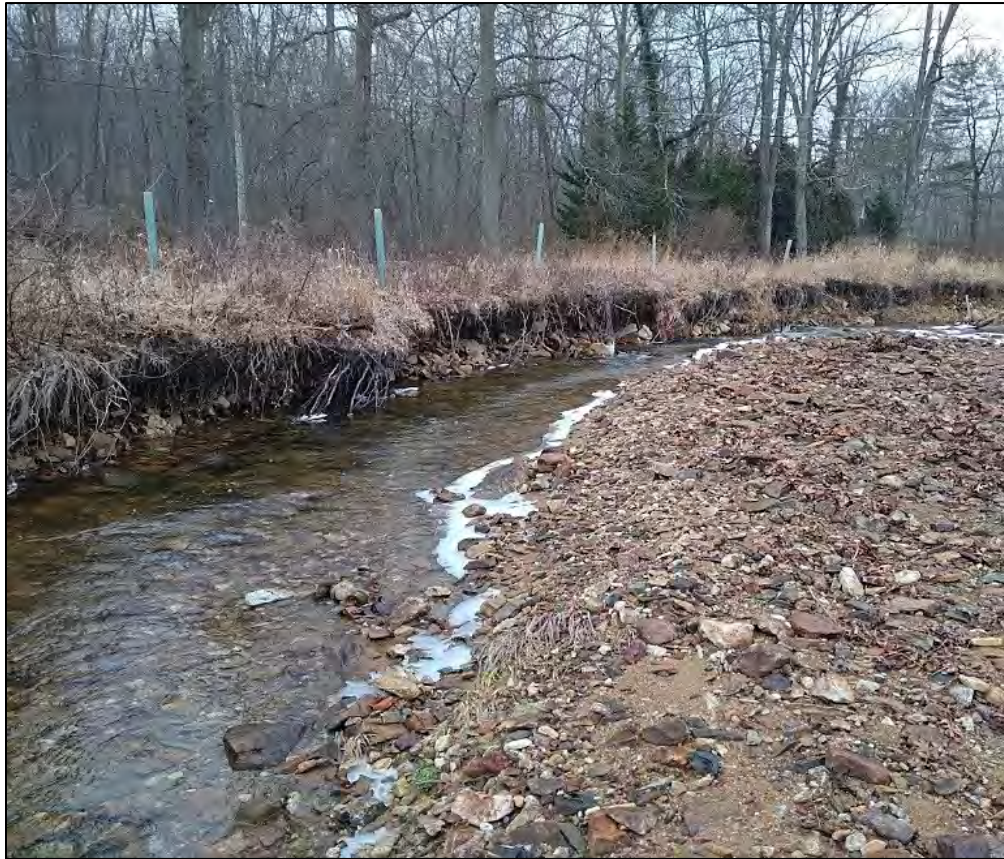
Figure 3: A newly formed stream channel threatens riparian plantings. The streambanks remain very unstable with sluffing and over hanging streambanks.
