Blue Marsh Lake Shoreline Rehabilitation
2022 NFHP Bass Pro Grant

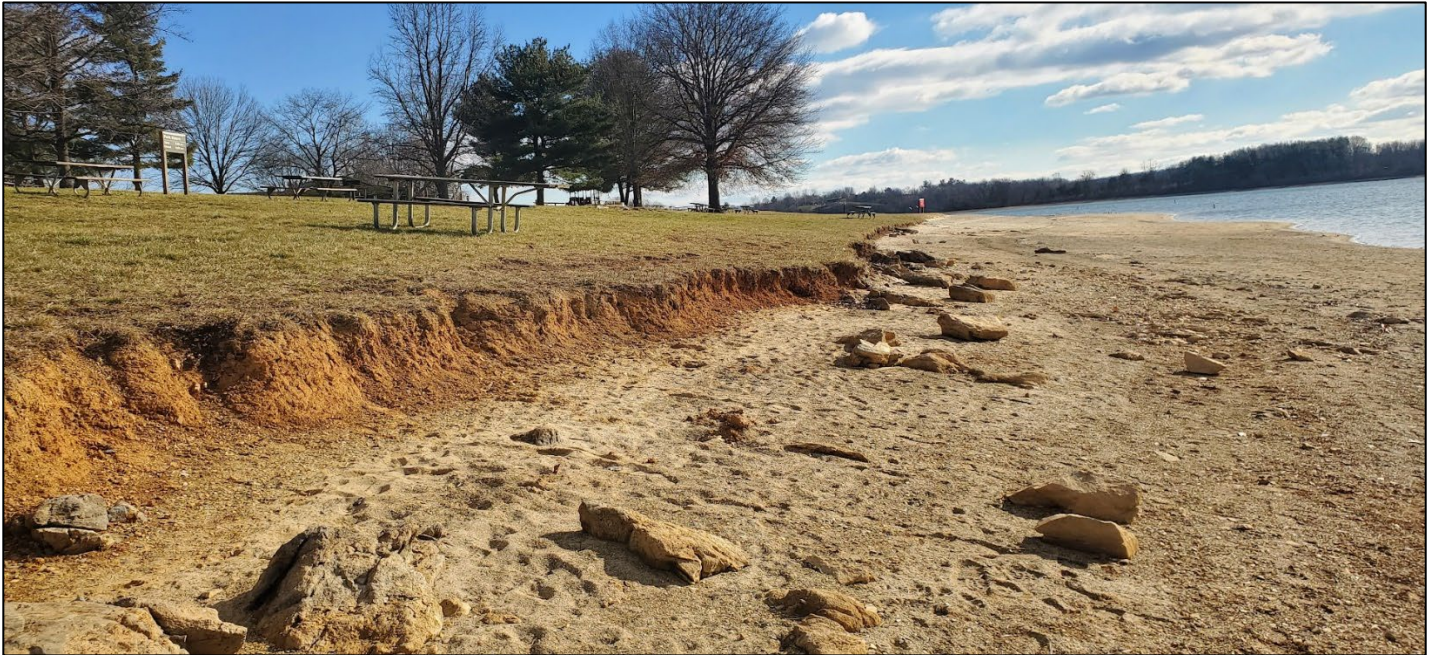
Figure 1: Shoreline erosion from wave and wake action at the Dry Brooks Day Use Area. The area is popular swimming and picnic area and is highly used by the public and mooring boaters.

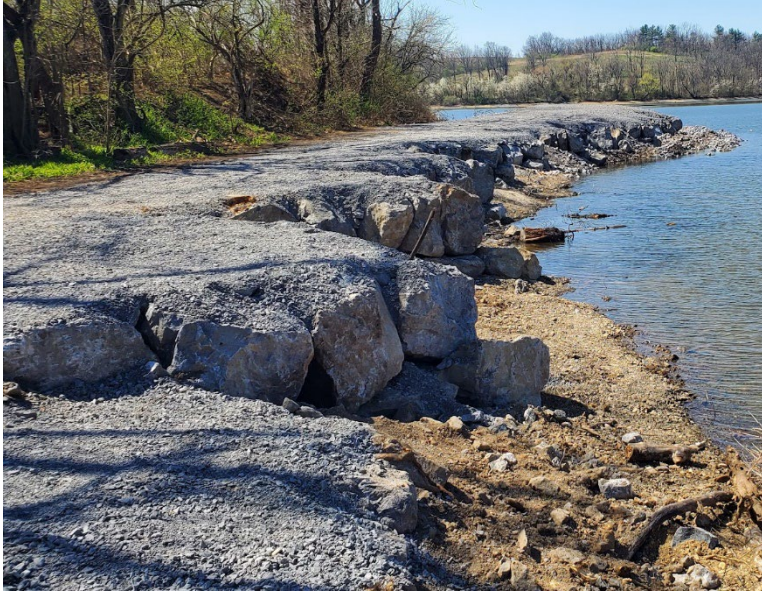
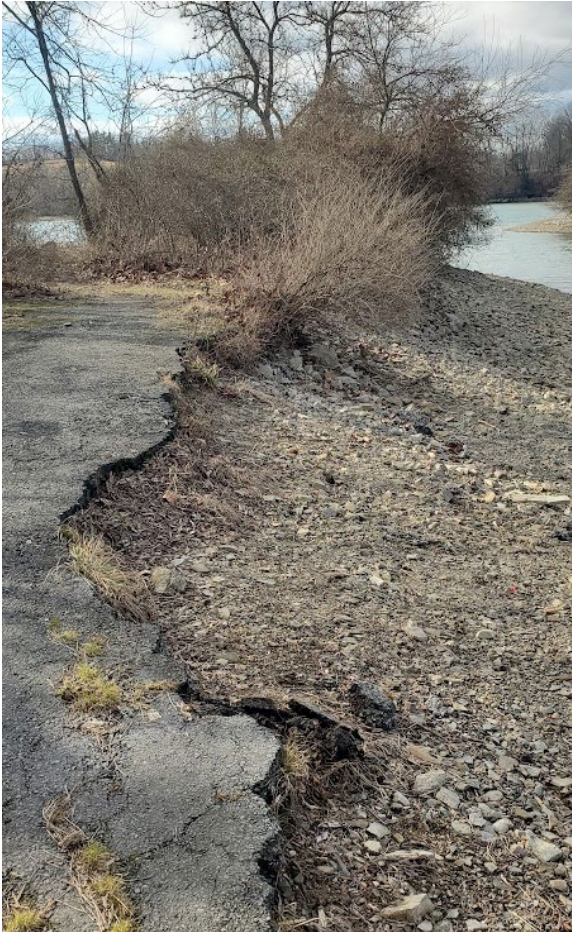
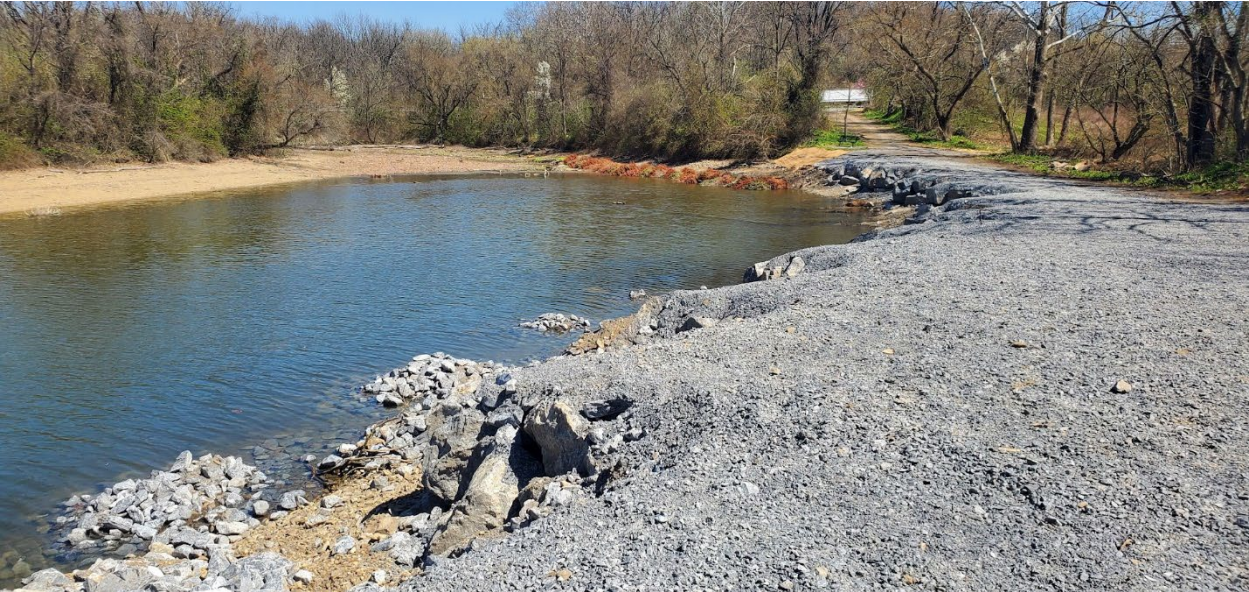
Figure 3-5: Old Church Road Access - Stone Framed Deflectors with an improved kayak and small craft boat slip. The lake is beginning to fill to summer pool elevation.
